DEVELOPMENT OF AN ACCELERATED
STRESS-CORROSION TEST FOR
FERROUS AND NICKEL ALLOYS

NOR 68-58

FINAL SUMMARY REPORT
Covering the Period March 1966 to March 1968

Northrop Corporation, Norair Division
3901 West Broadway,
Hawthorne, California 90250
Research and Technology Section
A. H. Freedman (Author)

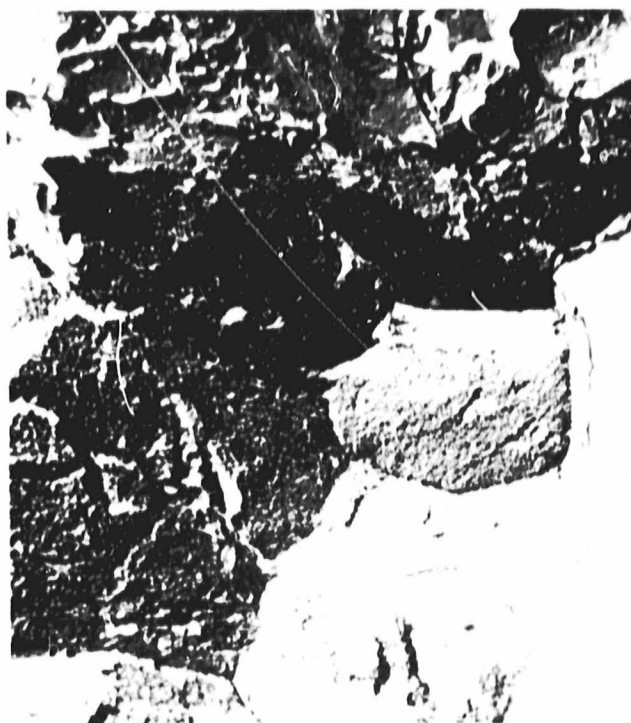
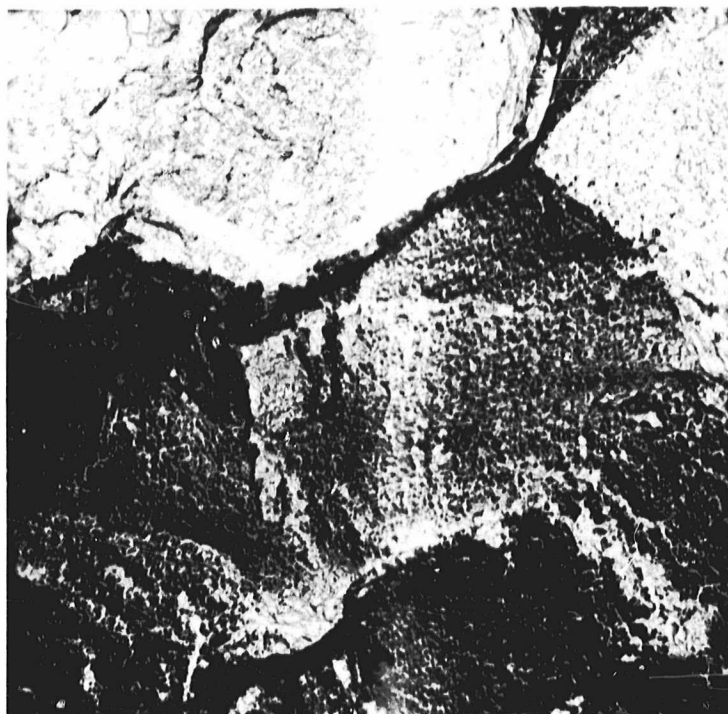
FIGURE 21 ELECTRON FRACTOGRAPHS OF STRESS-CORROSION FRACTURES OF AIR-MELTED H-11 (1000F TEMPER)

SPECIMEN A38 SEACOAST TEST

$$K_{Ii} = 26.7 \text{ ksi} \sqrt{\text{in}}$$

SPECIMEN A40 ACCELERATED TEST

$$K_{Ii} = 29.2 \text{ ksi} \sqrt{\text{in}}$$

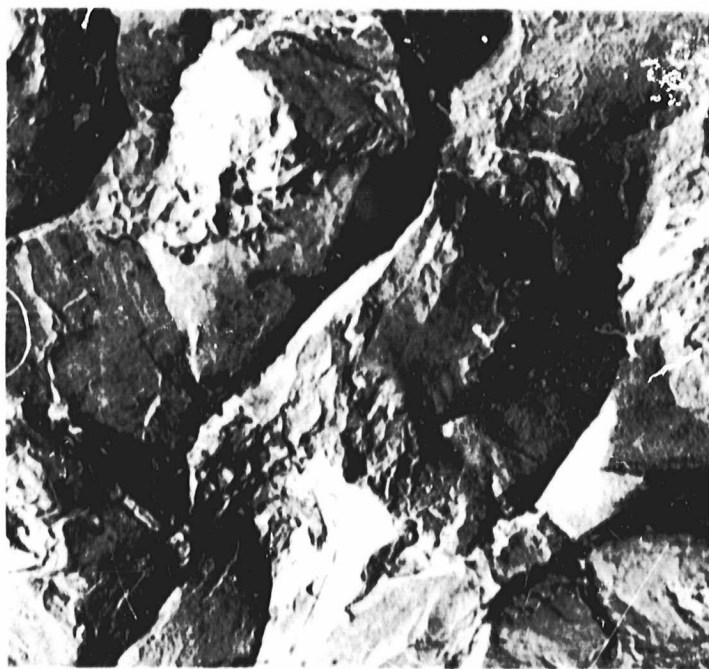
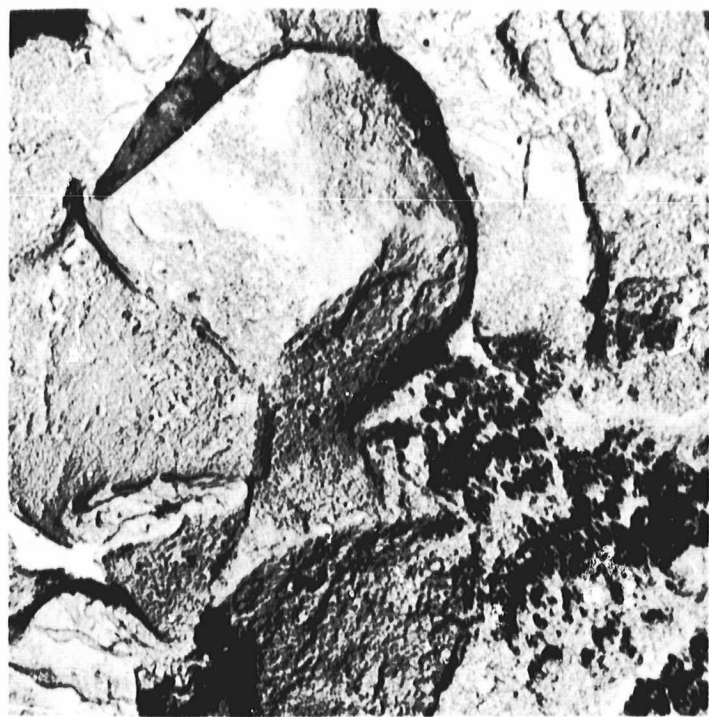
FIGURE 22 ELECTRON FRACTOGRAPHS OF STRESS-CORROSION FRACTURES OF 4340 (475F TEMPER)

SPECIMEN C9 SEACOAST TEST

$$K_{Ii} = 43.2 \text{ ksi} \sqrt{\text{in}}$$

SPECIMEN C13 ACCELERATED TEST

$$K_{Ii} = 35.9 \text{ ksi} \sqrt{\text{in}}$$

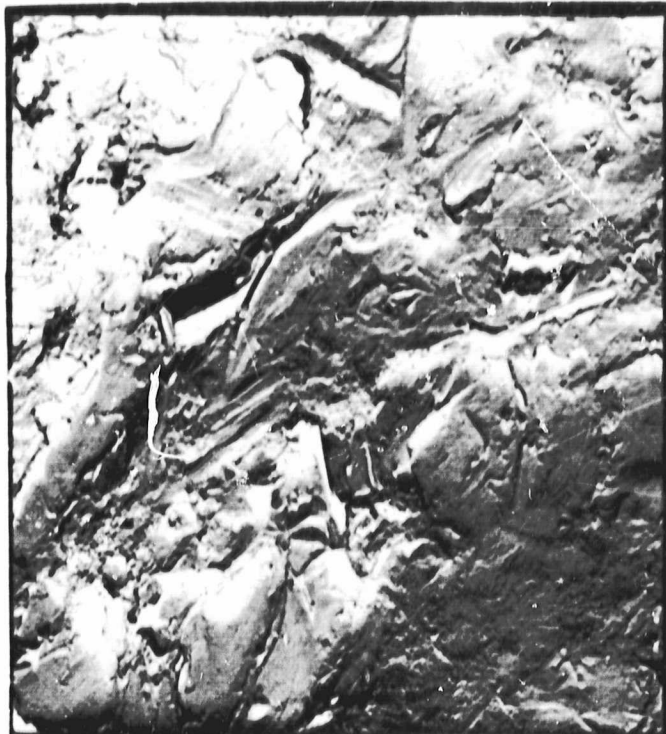
FIGURE 23 ELECTRON FRACTOGRAPHS OF STRESS-CORROSION FRACTURES OF 18Ni-250 (900F) MARAGING STEEL

SPECIMEN B5 SEACOAST TEST

$K_{Ii} = 93.8 \text{ ksi} \sqrt{\text{in}}$

SPECIMEN B14 ACCELERATED TEST

$K_{Ii} = 82.5 \text{ ksi} \sqrt{\text{in}}$

Electron fractographs of 18Ni Maraging steel are shown in Figure 23. The seacoast specimen had a semi-featureless topology which was intergranular in nature. The smooth grain-like facets and grain boundaries were not as well defined as in classical examples whereas the stress-corrosion zone of the accelerated test specimen revealed a well defined, intergranular mode of propagation. Grain boundaries were very evident, and a small amount of corrosion product was visible as particles on the grain faces.

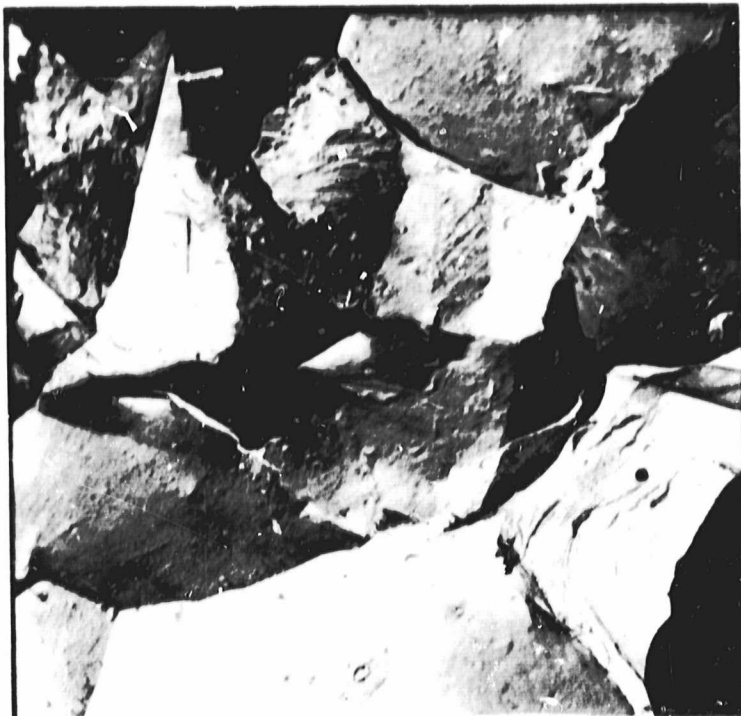
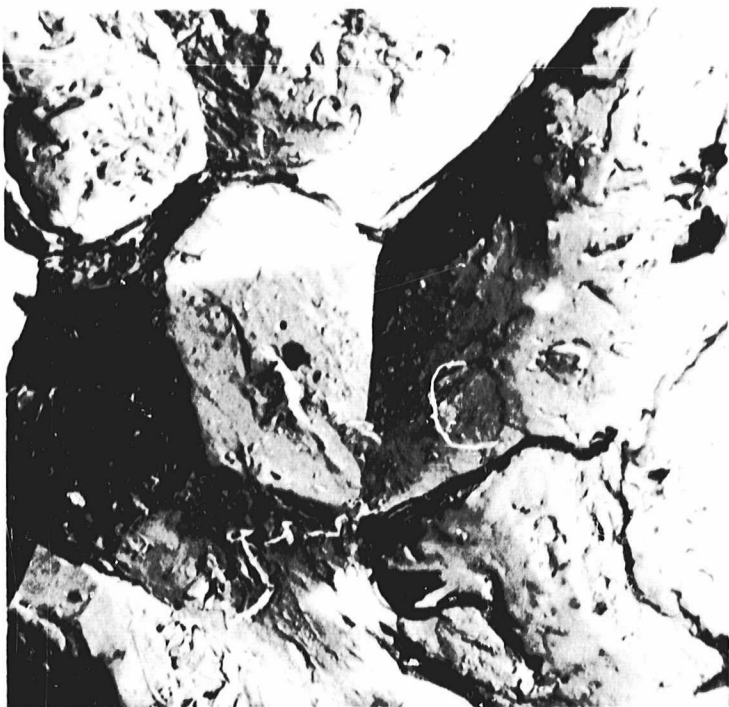
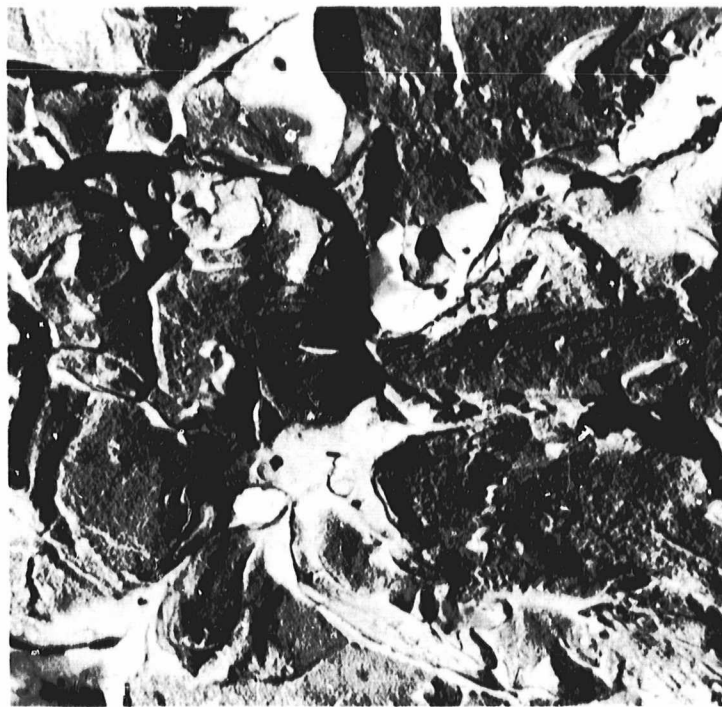
SPECIMEN E5 SEACOAST TEST

$$K_{Ii} = 76.0 \text{ ksi} \sqrt{\text{in}}$$

INTERGRANULAR FRACTURE REGION

TRANSGRANULAR CLEAVAGE REGION

Figure 24 shows fractographs of 410 tempered at 650F and tested at stress intensities well above both threshold values and allowable plane-strain loading conditions. Seacoast specimens revealed only intergranular stress-corrosion fracture, as evidenced by the sharp pyramidal facets. Very slight corrosion of the fracture facets was noticed. Analysis of the accelerated-test specimen revealed a mixed-mode fracture. Both intergranular and transgranular cleavage fracture were found. The relative proportion of intergranular-to-cleavage mode was approximated at 4:1. Hydrogen embrittlement generally produces a quasi-cleavage fracture mode in 410 tempered at 650F-700F;¹⁸ the presence of cleavage in the accelerated-test specimen suggested that hydrogen embrittlement may have contributed to failure.

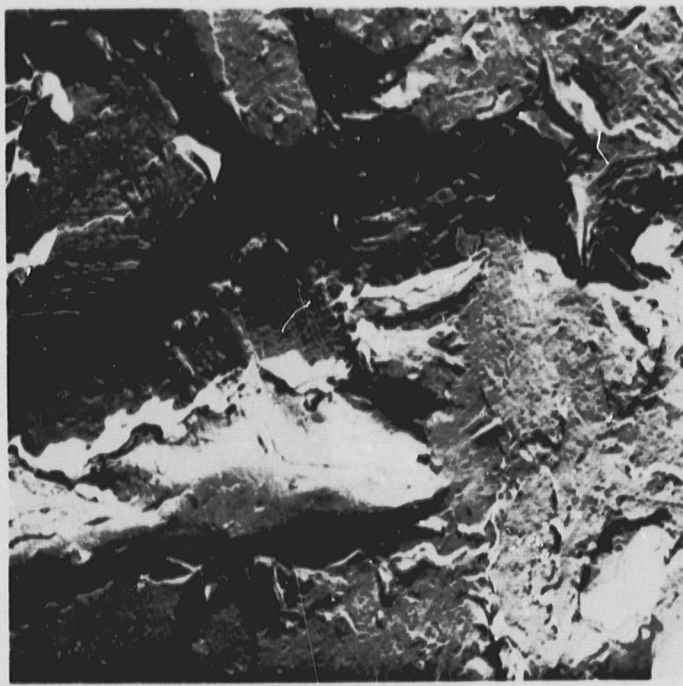
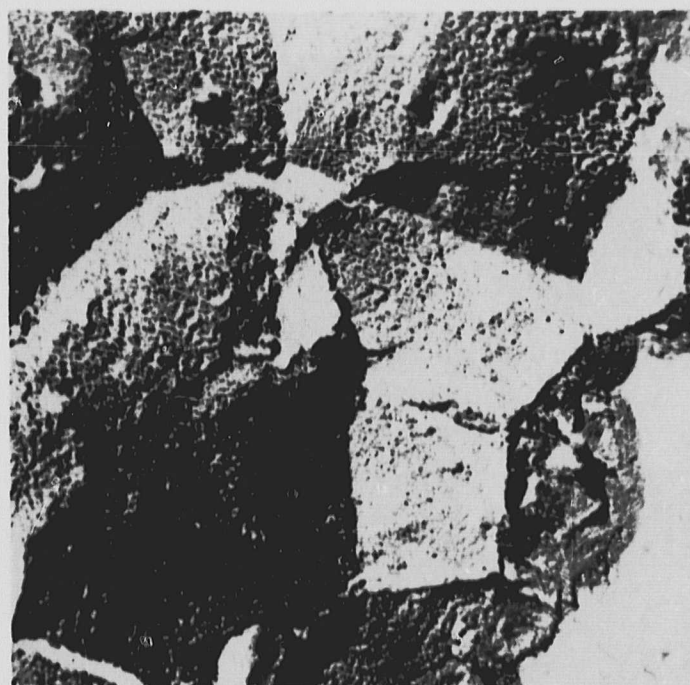
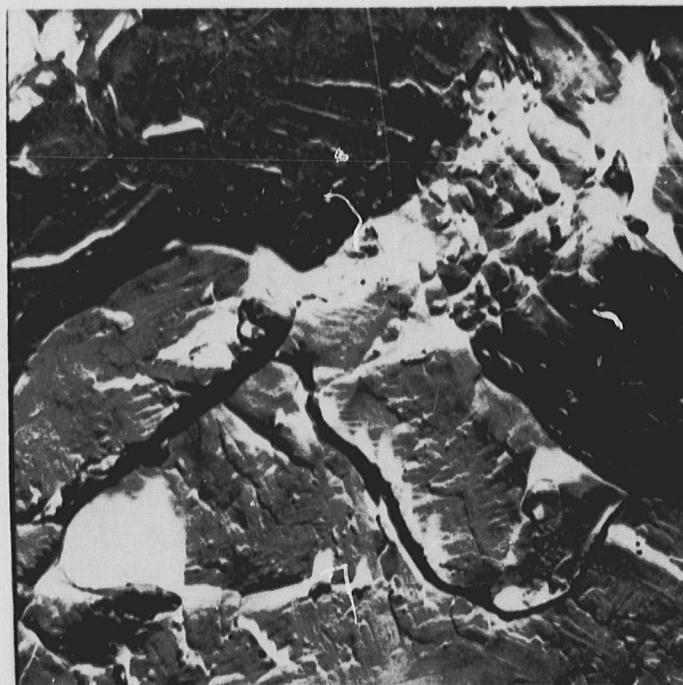
FIGURE 26 ELECTRON FRACTOGRAPHS OF STRESS-CORROSION FRACTURES OF 17-4 (H900)

INTERGRANULAR FRACTURE REGION

TRANSGRANULAR FRACTURE REGION

SPECIMEN F7 SEACOAST TEST

$$K_{I1} = 44.1 \text{ ksi} \sqrt{\text{in}}$$

$$K_{I1} = 43.0 \text{ ksi} \sqrt{\text{in}}$$

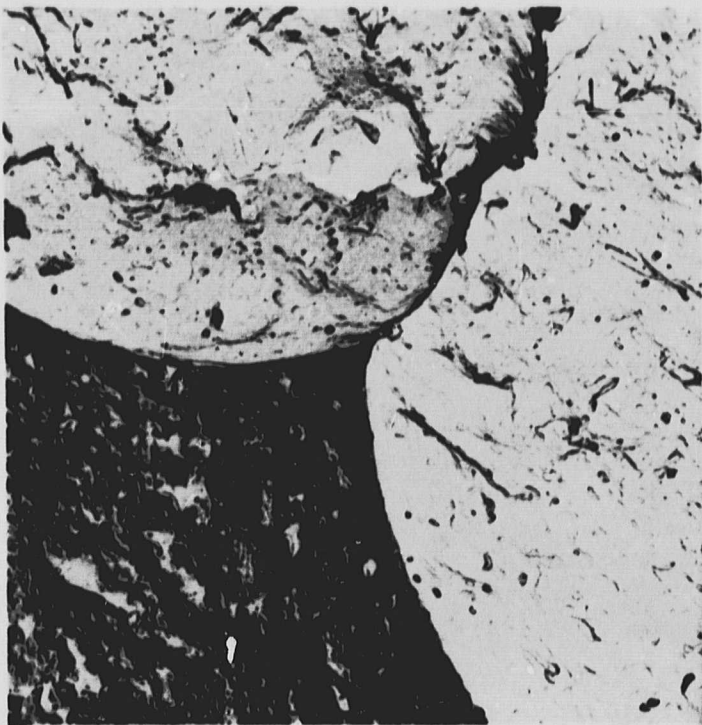
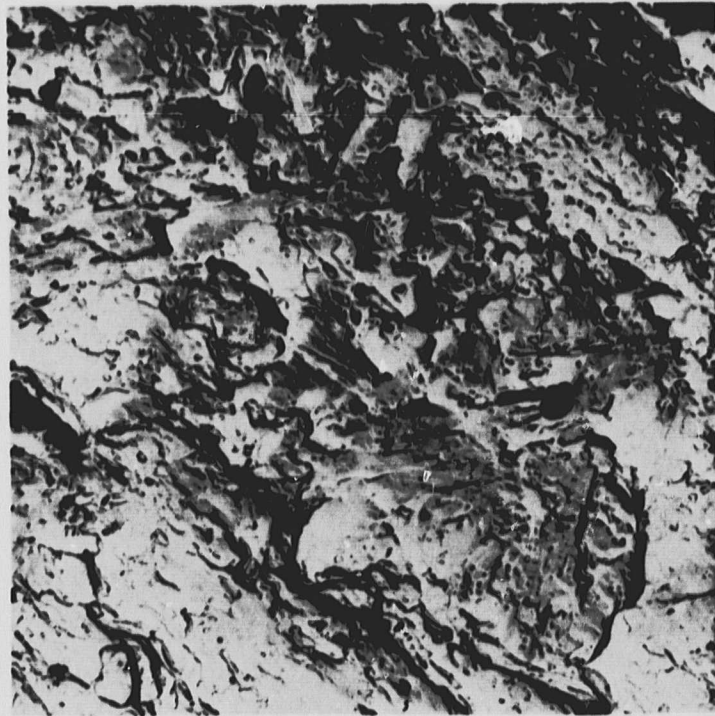
SPECIMEN G4 SEACOAST TEST

$$K_{I1} = 28.7 \text{ ksi} \sqrt{\text{in}}$$

INTERGRANULAR FRACTURE REGION

QUASI-CLEAVAGE TRANSGRANULAR REGION

Figure 27 shows typical electron fractographs taken from the stress-corrosion propagation zone of AM355 heat treated to the SCT850 condition. Fracture was found to be intergranular in both the seacoast-and accelerated-test specimens. This was evidenced by the smooth grain facets observed in both fractographs. The accelerated-test specimen G27 did, however, show isolated areas of quasi-cleavage type transgranular fracture. Specimens G5, loaded to a K_{Ii} of $35.4 \text{ ksi}\sqrt{\text{in.}}$ in the seacoast environment, and G28, loaded to a K_{Ii} of $34.7 \text{ ksi}\sqrt{\text{in.}}$ in the accelerated test, also were examined fractographically. At this higher stress intensity, the seacoast specimen still exhibited an intergranular fracture mode. The fracture mode of the accelerated-test specimen changed from essentially intergranular fracture to approximately 80-percent transgranular quasi-cleavage and 20-percent intergranular fracture. However, the results on specimens of Figure 27 were considered to be more significant because K_{Ii} values were closer to the K_{ISCC} value.
